Product Service Bulletin

Vol. 3, December 2002

Current Trends Bearing Down On Electrical Stress Can Protect A Motor

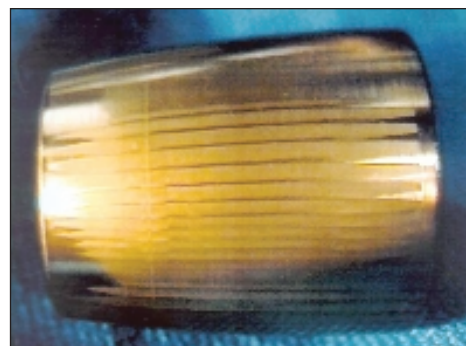
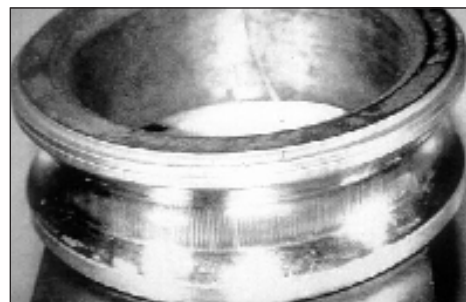
Noisy bearings or repeated bearing failures can be an indication of electrical stress. Only after the bearings have been removed and inspected can this problem be diagnosed. Otherwise, the motor will continue to operate until the bearings fail and the motor is so

Fluting due to shaft currents on both a roller bearing, above, and a ball bearing, below.

Indications of shaft voltages include "fluting" or a "picket-fence" signature on the race of the bearing. Fluting due

to shaft currents can occur on both a roller bearing and a ball bearing. The spacing of the fluting marks depends on the rpm, diameter, radial load and magnitude of the shaft voltage. In some cases, the appearance of the balls offers the best clue. Instead of a highly-polished finish, the rolling elements may have a dull grey or smoky appearance.

US Motors suggests using a protective ceramic coating on the bearings when the bearings indicate shaft currents are present and have caused the failure. This approach may not be practical on smaller size motors, however, some bearing manufacturers do offer an anti-friction bearing with an insulated outer race or rolling element.

- Use bearings with ceramic balls.
- Insulate both bearing housings.
- Install ground brushes on both ends.
- Insulate both shaft journals.
- Install in-line filters between the motor and VFD to reduce the problem.
- Improve grounding of the motor and drive.

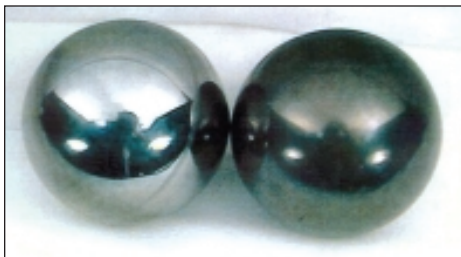
When rotational speed varies, the shaft currents may cause a dull, frosted appearance instead of fluting.

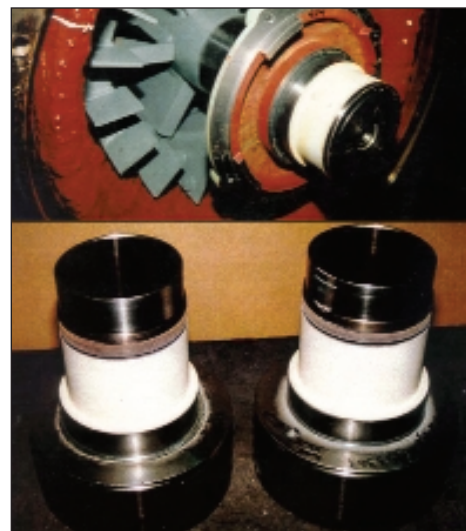
Ceramic or aluminum oxide spray is one method of insulating. Above, an opposite drive end bearing journal, and below, vertical motor bearing carriers, all of which have been insulated with ceramic spray.

The practice at US Motors is to insulate the non-drive end shaft bearing journal with a ceramic (aluminum oxide) coating. Insulated sleeve bearings are purchased with the outer diameter insulated by the bearing manufacturer. Insulated bearings are provided as a standard feature on all US Motors products in the 5800 through 9600 frame series, all Titan 6 pole motors, Titan sleeve bearings motors and Titan

EASA shops receiving a US Motors brand motor for repair are encouraged to re-coat the materials before installing new bearings, if the ceramic was damaged. Keep in mind that when insulating a bearing housing, you must also insulate the face of the bearing cap. The bearing cap could come into contact with the face of the bearing, bypassing any insulation on the bearing housing.

Be sure to take special care when applying the ceramic coating because ceramic chips easily. Care should also be taken when balancing a shaft with ceramic-coated journals because the layer of ceramic is relatively thin. The rotor weight should not be placed on the journals for balancing or inspection because the point-loading is likely to break the ceramic loose from the shaft. The damage does not show up until the motor is in service, at which time the ceramic fractures, leaving the bearing with a loose shaft fit.
