Product Service Bulletin

Vol. 1, October 2002

Tips to Identifying and Preventing Overloads and Environmental Contamination

Emerson Implements Motor Upgrades Based on Program Results

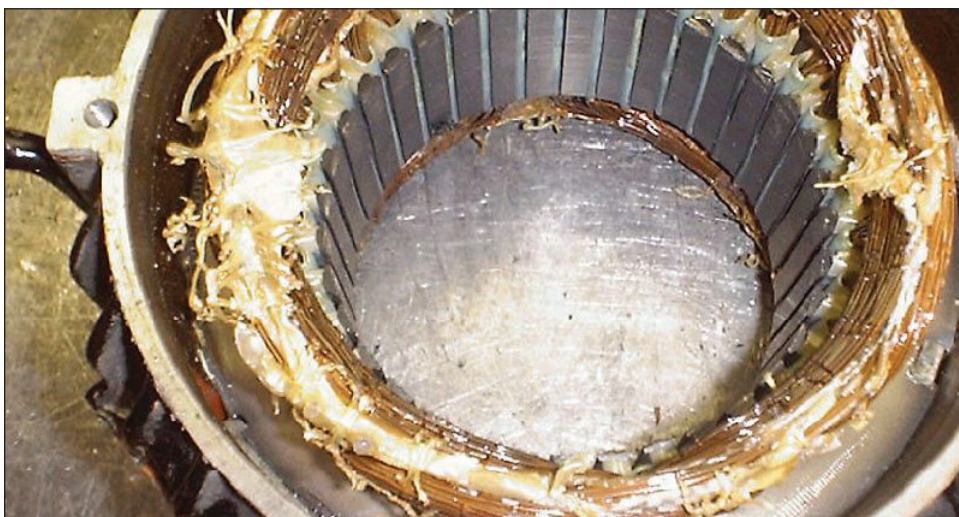
Popped strings and melted phase paper indicate overload.

Another common cause of motor failure is overloading. When investigating a potentially overloaded motor, the following questions will yield important clues: What are the three-phase full load amps and voltages? Has the application on the motor changed since its original installation? Was the motor sized properly?

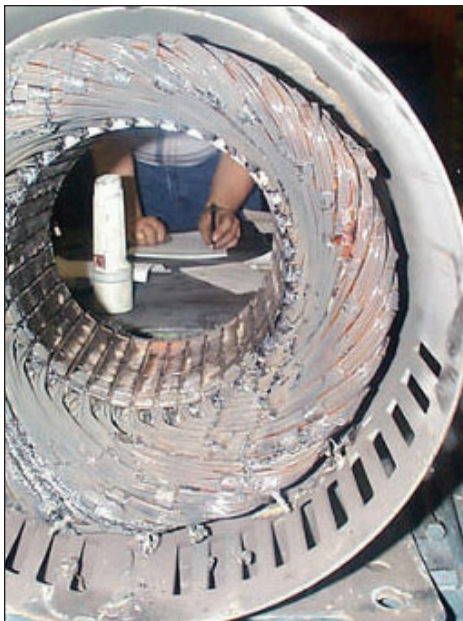
Generally discolored winding of an overloaded motor.

An overloaded motor will have a general burnt appearance in the winding (see photo). A winding failure resulting from a defect in the motor, which is warrantable, will be more localized in nature.

Overload can occur when the driven load is larger than the motor is capable of handling or if insufficient voltage is applied

at the motor terminals. A motor that does not have proper ventilation and overheats is a form of overload. It is difficult to distinguish between the causes for a "roasted" winding, i.e., overload, low voltage, or ventilation, since the results are similar. Emerson requires that the ambient air temperature used for cooling the motor not exceed the rated ambient on the nameplate, typically 40 C (104 F). If the motor is operated in an enclosed or restricted area, a sufficient quantity of cooling air must be supplied as determined by Emerson with a maximum temperature of 40 C (104 F).

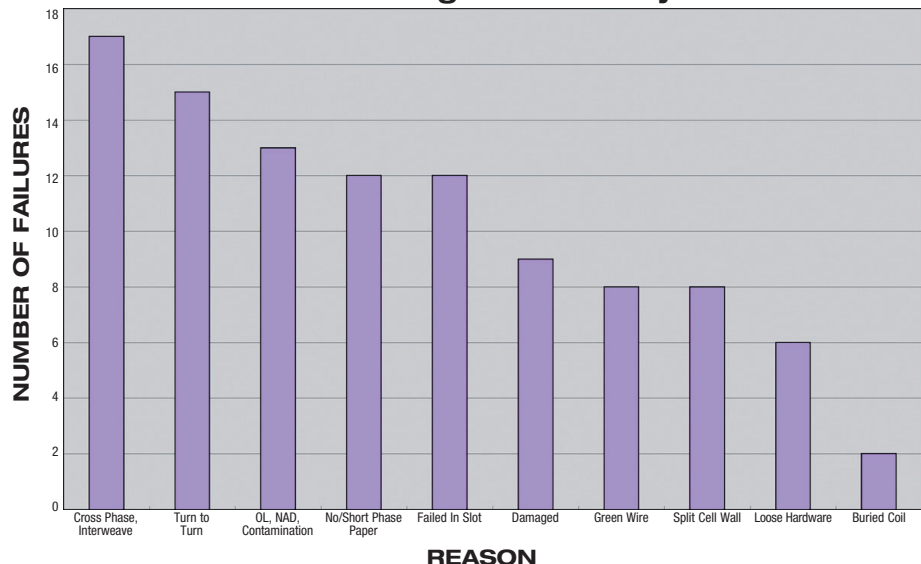
Pareto of Reasons Found During NEMA Winding Failure Analysis

Emerson identified the top 10 causes for the failures and has implemented an internal plan for researching and resolving those issues that pertain to the physical components of its motors:

1. Crossed phase wires, interwoven wires in the end turn
2. Turn to turn shorts
3. Overloads, no apparent defects and contamination (not covered under warranty)
4. Absence of or short phase paper
5. Failed in slot
6. Damaged wire
7. Green wire (caused by moisture contamination)
8. Split cell wall liner
9. Loose hardware (bolts, balance washers, etc.)
10. Buried coil

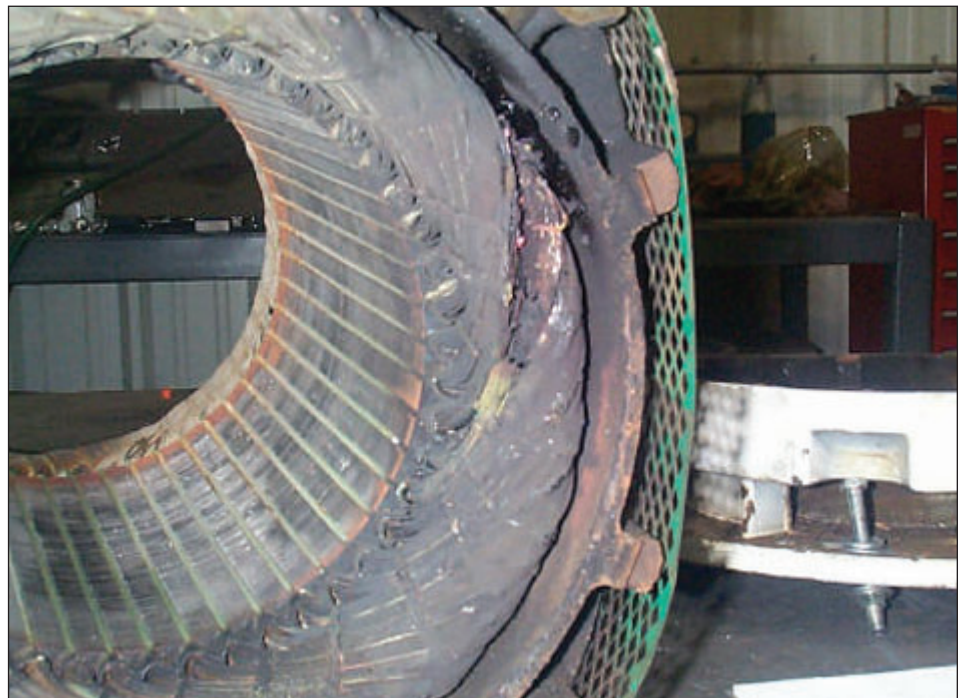
One common cause of motor failure is water damage within a motor (see image). This can often be identified by the presence of rust, telltale water lines and green specs

(copper oxides) on the winding. A low megger reading can also indicate water contamination.

Rust from moisture contamination

Emerson motors are constructed for both indoor and outdoor use. If the motors are going to be used outdoors, they may be subject to humidity and moist environments. Some basic precautions are recommended when installing an Emerson motor outdoors that will help prevent moisture damage, such as using a space heater or trickle

voltage heating. Heaters will keep the winding above the dew point and prevent moisture from collecting on the winding and other internal parts. Enclosed motors, by the nature of their construction, help prevent these contaminants from entering the motor. Large open motors may utilize an available filter accessory to control the ingress of contaminants.
