Product Service Bulletin

Vol. 2, November 2002

Belt Watch Identifying Improper Belting Applications Early Can Save A Motor

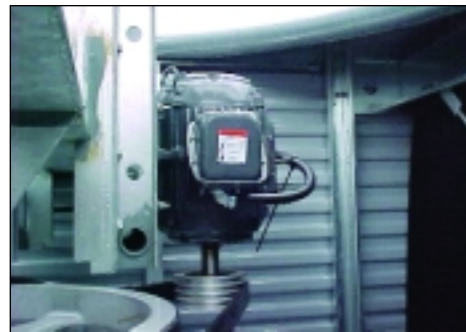
Motor sheave mounted on end of shaft and beyond center point of sheave. Motor shaft eventually snapped.

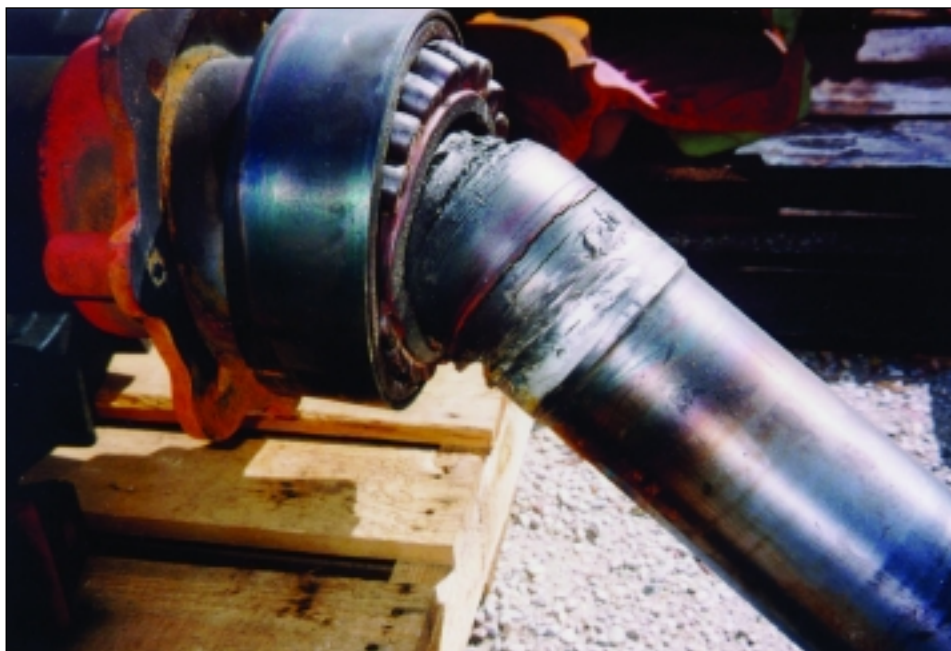
Motor failed due to mismatched and over-tightened sheaves causing excessive heat and melting motor shaft.

excessive a broken shaft can result. Proper alignment of sheaves is very important in preventing failure. If not properly aligned, the belts will wear incorrectly, causing excessive vibration, broken belts, bearing failure, etc. Correct sheave diameter ratios are a must. Getting the incorrect ratio of drive sheave to driven sheave can result in not enough belt contact with the sheave allowing the belts to slip. Mounting a sheave at the end of the shaft will not only turn the shaft into a lever, dramatically increasing the chance of breaking the shaft, but it also increases the load on the bearing.
